8 CORROSION TESTS

Overview

This chapter details the evaluation of the galvanic corrosion of two advanced conductors (ACCC and C7) after an intensive thermomechanical cycle aging procedure corresponding to 40 years of operation.

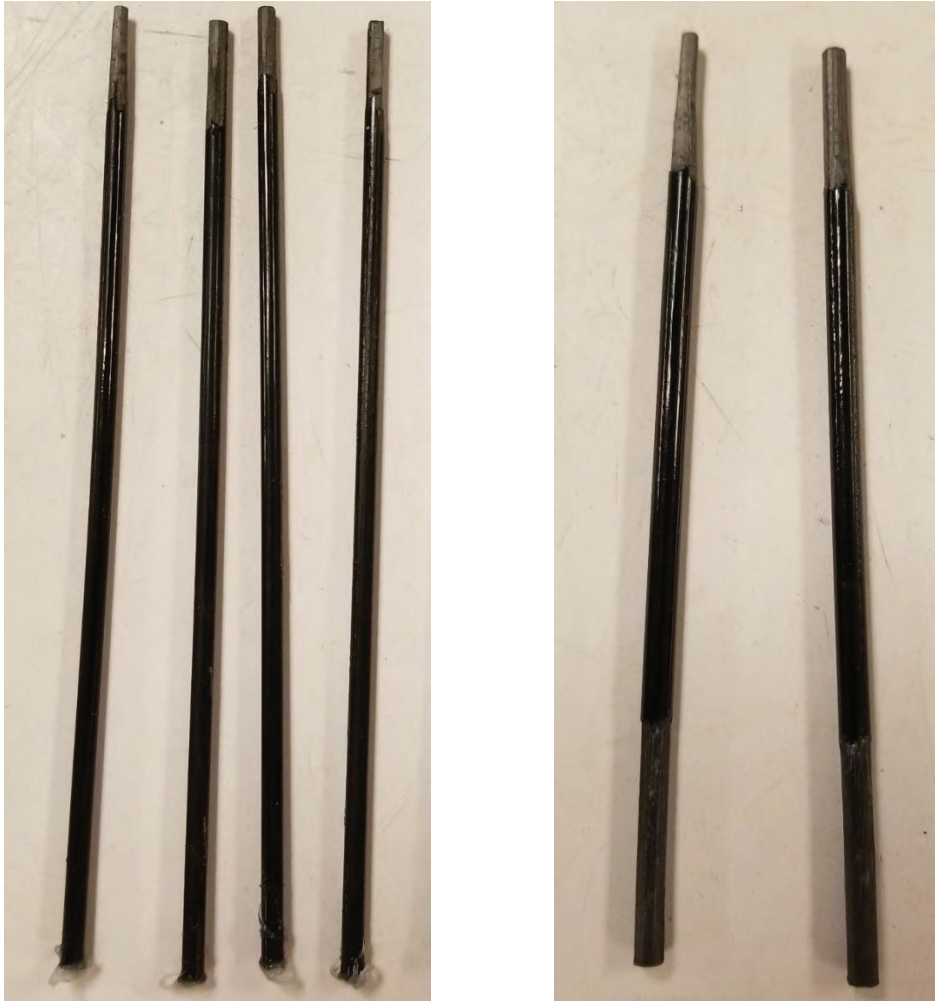
Figure 8-2. Coated Southwire C7 carbon strands (left) and uncoated Southwire C7 carbon strands (right).

Carbon fiber strands from the C7 ACCR conductor were prepared in two different ways as shown in Figure 8-2. . Test strands were cut into a 6-inch-long segment, one end was stripped of the protective layer (PEEK) to provide an electrical connection point for the instrument (ammeter), and the other end tip was covered with silicon (to cover the exposed carbon due to the cut). This preparation was used to assess coated carbon fiber strands from a new conductor and a carbon fiber strand from an aged conductor. The second preparation involved stripping one end of the 6-Inch-long strands to provide an electrical connection point, while the other end was stripped of the PEEK layer to expose exactly 1 in. of the strands. Each preparation also involved the use of electrical tape to control the amount of area exposed to the electrolyte, like the preparation of aluminum strands as seen in Figure 8-2.

It was noted that the PEEK layer of the C7 ACCR conductor carbon fiber strands was hard and difficult to remove. This finding shows that the PEEK layer is highly resistant to abrasion which is an indication that the carbon core is unlikely to be exposed directly to aluminum.

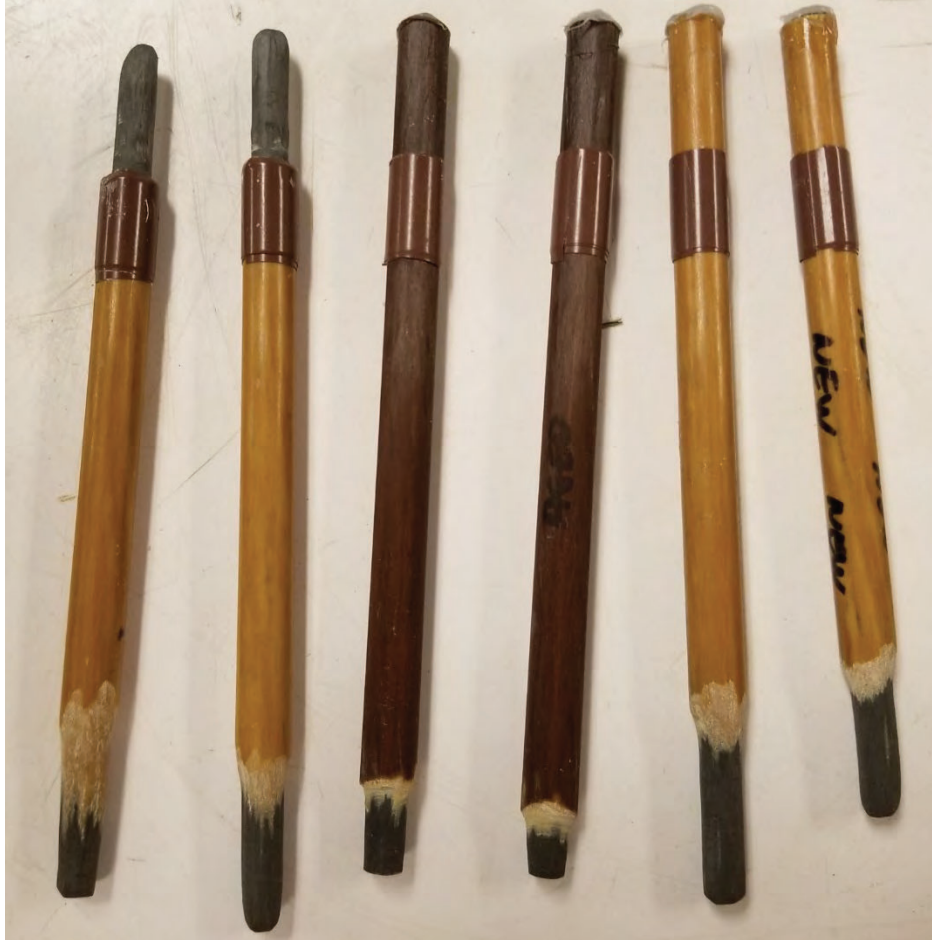
Figure 8-3. CTC cores prepared for testing: exposed core from new conductor (2 left samples), coated core from aged conductor (2 middle samples), and coated core from new conductor (2 right samples).

The carbon core preparation for the CTC ACCC conductor was done in a similar manner to the C7 ACCR strands as shown in Figure 8-3. Like the PEEK layer, the glass fiber protection layer in the CTC ACCC connector was difficult to remove. A grinder with an abrasive tip was used to remove the protective layer and exposed the carbon fiber. This also suggests that it is unlikely that the carbon core will be directly exposed to the aluminum strands during regular operation.

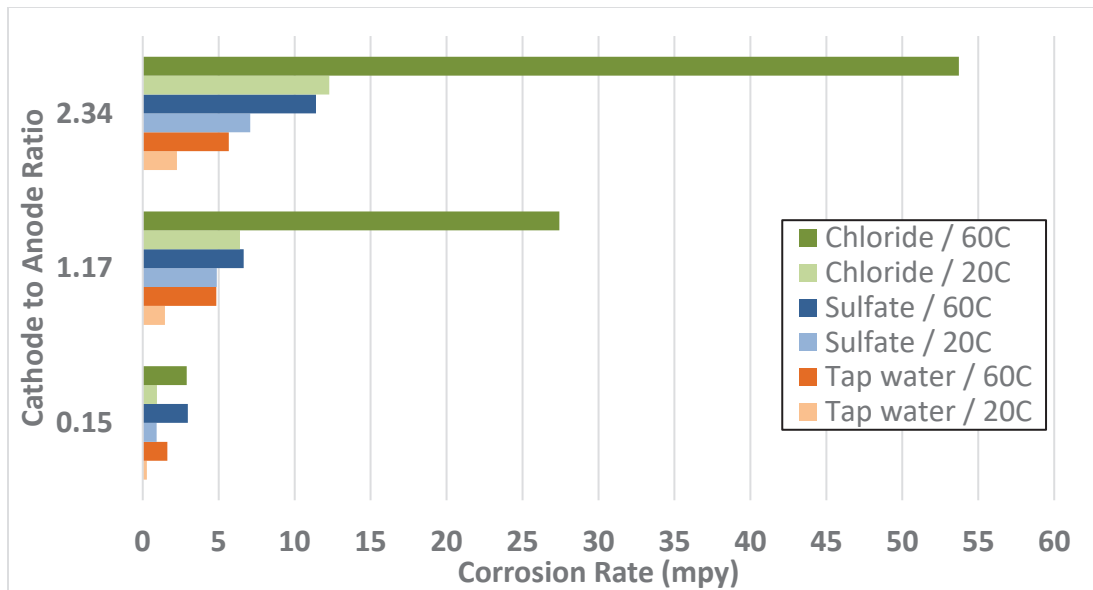
Figure 8-4. Aluminum Corrosion rate when exposed to CTC Global ACCC uncoated carbon core

Corrosion rates of aluminum strands exposed to an uncoated (glass fiber removed) carbon core from a new CTC ACCC conductor are shown in Figure 8-4. Its anode shows the effect of the different solutions, temperatures, and cathode to anode ratios on the corrosion rate of aluminum in contact with bare carbon fiber.

Several observations can be drawn from Figure 8-4:

- As the cathode to anode ratio increased, so did the aluminum corrosion rate
- As the temperature of the solution increased, so did the aluminum corrosion rate
- Chloride solution results in the highest corrosion rate followed by sulfate solution and tap water
- The highest corrosion rate was observed with hot chloride solution with a cathode to anode ratio of 2.34. This corrosion rate was extremely high with a value of 54 mils per year.

Cathode to anode ratios impact the corrosion rate in a predictable way. As more cathode surface area is exposed (high ratio), the demand for electrons is higher, hence the amount of electrons leaving the anode is higher, which leads to an increase corrosion rate. As the solution temperature increases, the corrosion rate increases. This is due to the thermodynamic nature of the corrosion process. Chloride solutions increase the corrosion rate due to two factors. First, chlorides increase the electrical conductivity of the solution which allows more ionic current to flow. Secondly, chloride ions are known to be strong depolarizers, which means that chloride ions can easily break down the microscopic protective layer formed on the aluminum surface. When exposed to the atmosphere, aluminum is highly corrosion resistant due to the formation of a thin layer of aluminum oxide at its surface (passivation layer), protecting the metal from corrosion. Chlorides, and to a lesser extent sulfates, easily break down the passivation layer increasing the corrosion of aluminum.

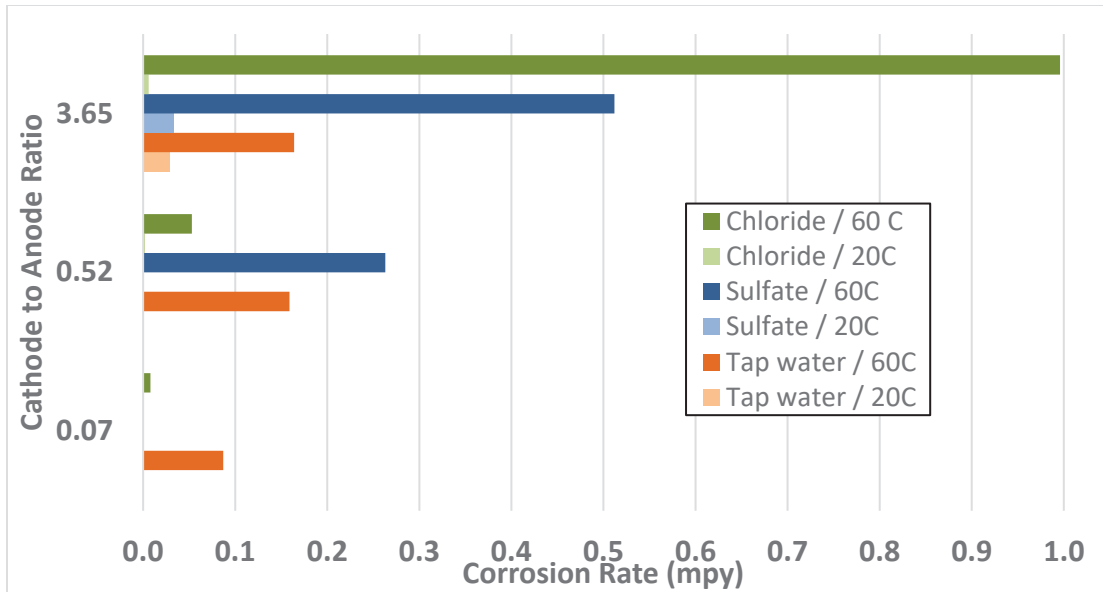
Figure 8-6. Aluminum corrosion rate when exposed to aged C7 ACCR carbon core

Corrosion rates of aluminum strands exposed to coated carbon core from aged C7 ACCR conductor are shown in Figure 8-6. Unlike the carbon core of the aged CTC ACCC Global conductor, which did not impact aluminum corrosion, the carbon strands of aged C7 ACCR conductor seemed to create a corrosion cell with the aluminum strands resulting in light corrosion of aluminum. However, the highest corrosion rate observed (60°C solution of chloride at the highest ratio) was 1 mil per year, which is a low value. Like the observations made earlier, solution temperature and cathode to anode ratio had a predictable impact of the corrosion rate of aluminum.

The difference between the corrosion rates at low cathode to anode ratios and the rates at high cathode to anode ratios is not as pronounced as the previous experiment. Moreover, at the lowest and medium ratios, tap water solutions resulted in a higher corrosion rate than chloride and sulfate (only at low ratio), a phenomenon that was not observed previously. This suggests that the results shown in Figure 8-6 should be taken with prudence due to the inconsistency of some data. It is probable that the tip of the carbon fiber strands were not perfectly coated with silicon during sample preparation, exposing the bare carbon fiber, even if visual inspection did not identify any problems.

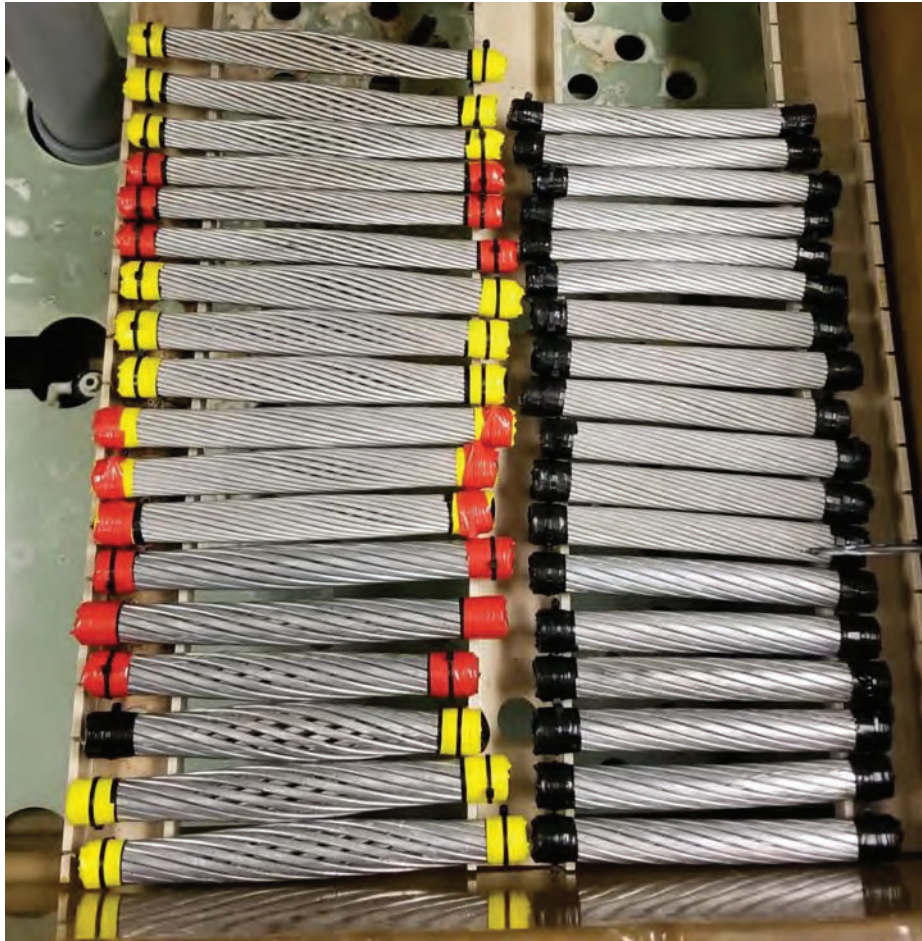
Figure 8-7. ACSS Conductor Samples

The effect of bird caging of the outer strands were evaluated in this study. Each conductor had 3 different types of samples.

5. Conductor sample with no birdcage
6. Conductor sample with a birdcage = 1.2 times the original diameter
7. Conductor sample with a birdcage = 1.4 times the original diameter

The samples are shown in Figure 8-7.

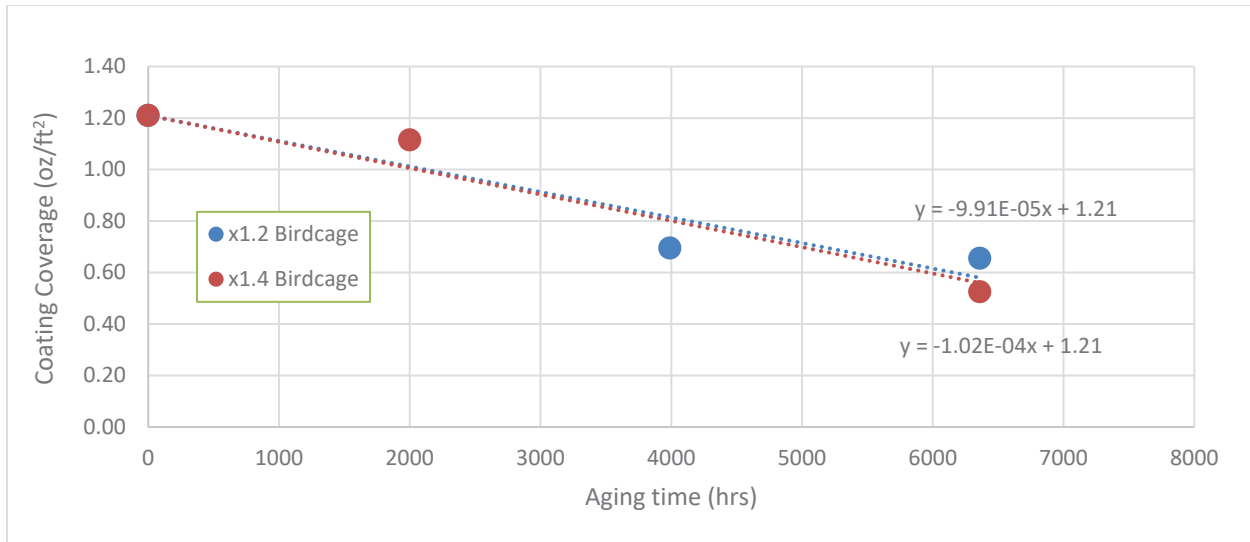
Figure 8-11. SW ACSS Suwannee birdcage effect on the steel core Mischmetal coating loss

A similar coating loss rate was measured for SW ACSS Suwannee conductor with bird caging. The coating loss rates were evaluated at 9.91×10^{-5} and 1.02×10^{-4} oz/ft²/hr. for the conductor with a birdcage diameter of 1.2 and 1.4 times the original diameter respectively, shown in Figure 8-11.

The coating loss rate for the SW ACSS Suwannee conductor, and its birdcage samples are summarized in Table 8-4. As expected, the coating loss rate for the birdcage samples were higher than for the conductor without any birdcage. A birdcage of 1.2 times the original diameter resulted in a coating loss rate increase of 1.15, while a birdcage of 1.4 times the original diameter resulted in the coating rate increase of 1.18.

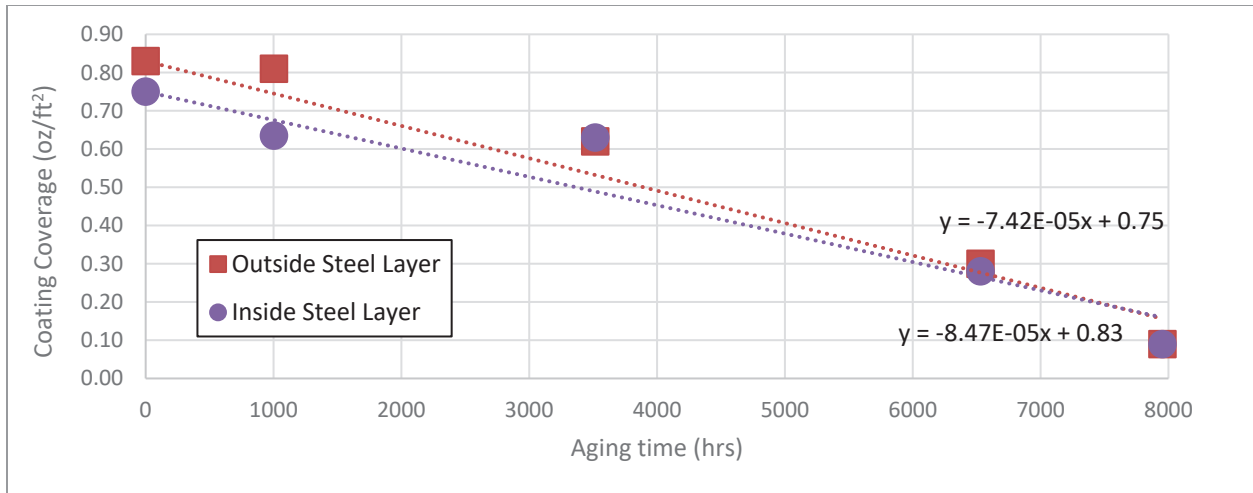
Figure 8-12. ZTT ACSS Mallard steel core Mischmetal coating loss due to aging

ZTT ACSS Mallard has two layers of round aluminum strands surrounding two layers of steel strands with a diameter of 0.0977 in. The coating loss rate for the two steel layers was measured separately. The full ZTT ACSS Mallard conductor has a diameter of 1.139 in. The Mischmetal steel coating loss due to aging is shown in Figure 8-12. The initial Mischmetal coating coverage was measured at about 0.80 oz/ft². The coating loss rate of the outside steel layer was measured at 8.47x10⁻⁵ oz/ft²/hr., while the coating loss rate of the inside steel layer was measured at 7.42x10⁻⁵ oz/ft²/hr. As expected, the inside steel layer had the lowest coating loss rate (0.87 times lower) than the outside one.

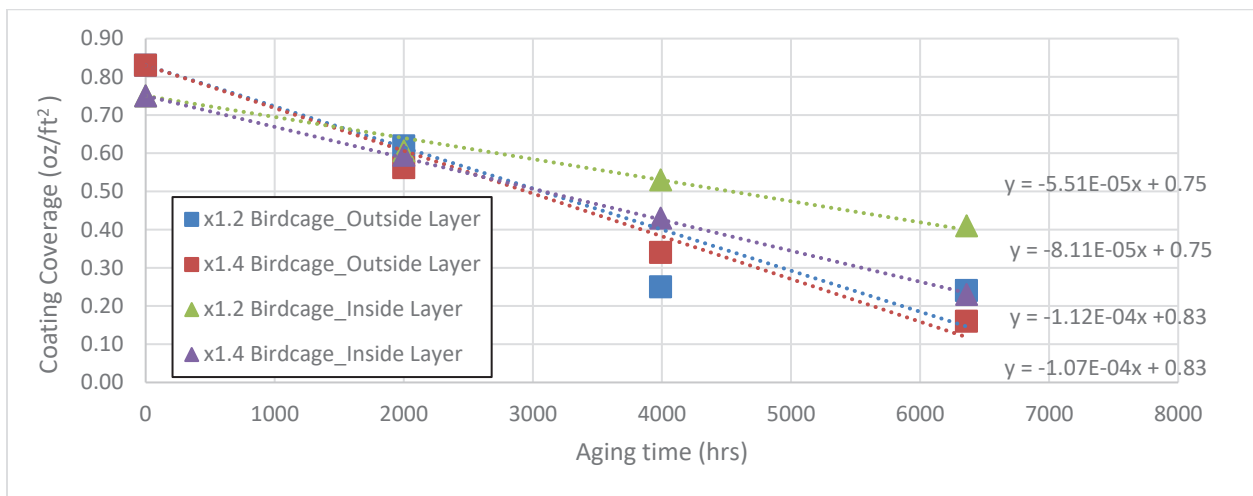
Figure 8-13. ZTT ACSS Mallard birdcage effect on the steel core Mischmetal coating loss

The Mischmetal coating loss rate was also measured for ZTT ACSS Mallard conductor with a birdcage. The coating loss rate of a conductor with a birdcage of 1.2 times the original diameter was measured at 1.07×10^{-4} oz/ft²/hr. for the outside layer and 5.44×10^{-5} oz/ft²/hr. for the inside layer. The coating loss rate of a conductor with a birdcage of 1.4 times the original diameter was measured at 1.12×10^{-4} oz/ft²/hr. for the outside layer and 8.04×10^{-5} oz/ft²/hr. for the inside layer, shown in Figure 8-13.

The coating loss rates of the ZTT ACSS Mallard conductor without and with bird cages are shown in Table 8-5. As expected, the birdcages increased the coating loss rate except for the inside steel layer of the birdcage with a diameter of 1.2 times the original diameter. The coating loss rate of the outside steel layer was increased by 1.26 and 1.32 for a birdcage of 1.2 times and 1.4 times the original conductor diameter respectively compared to the conductor without birdcage.
