# THE SL-1 REACTOR

## CHAPTER 15 - THE SL-1 REACTOR

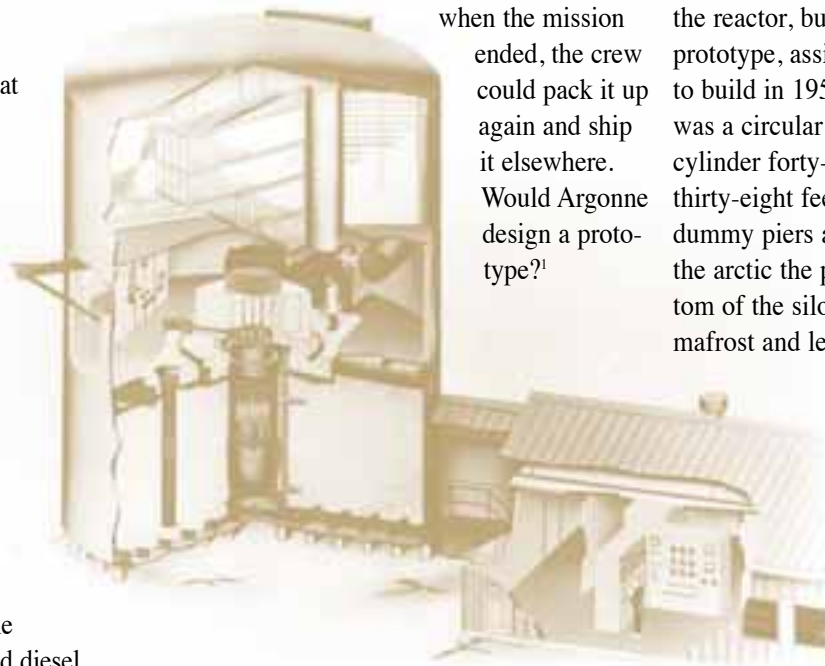
INEEL 60-3227

*Cutaway of SL-1 reactor and the control building. Reactor floor is above shielding gravel. Fan floor is above reactor floor.*

Inside, the plant was arranged like a three-layer cake. In the bottom third, native stone and gravel shielded the pressure vessel containing the reactor. The middle third was the operating level, giving the crew access to the top of the reactor, the turbine generator, and control rod machinery. On top, a “fan floor” attic contained equipment to condense and cool the recirculating water. A weather-protected stairway snaked up the side of the cylinder to connect the adjacent control building to the operating floor level.<sup>4</sup>

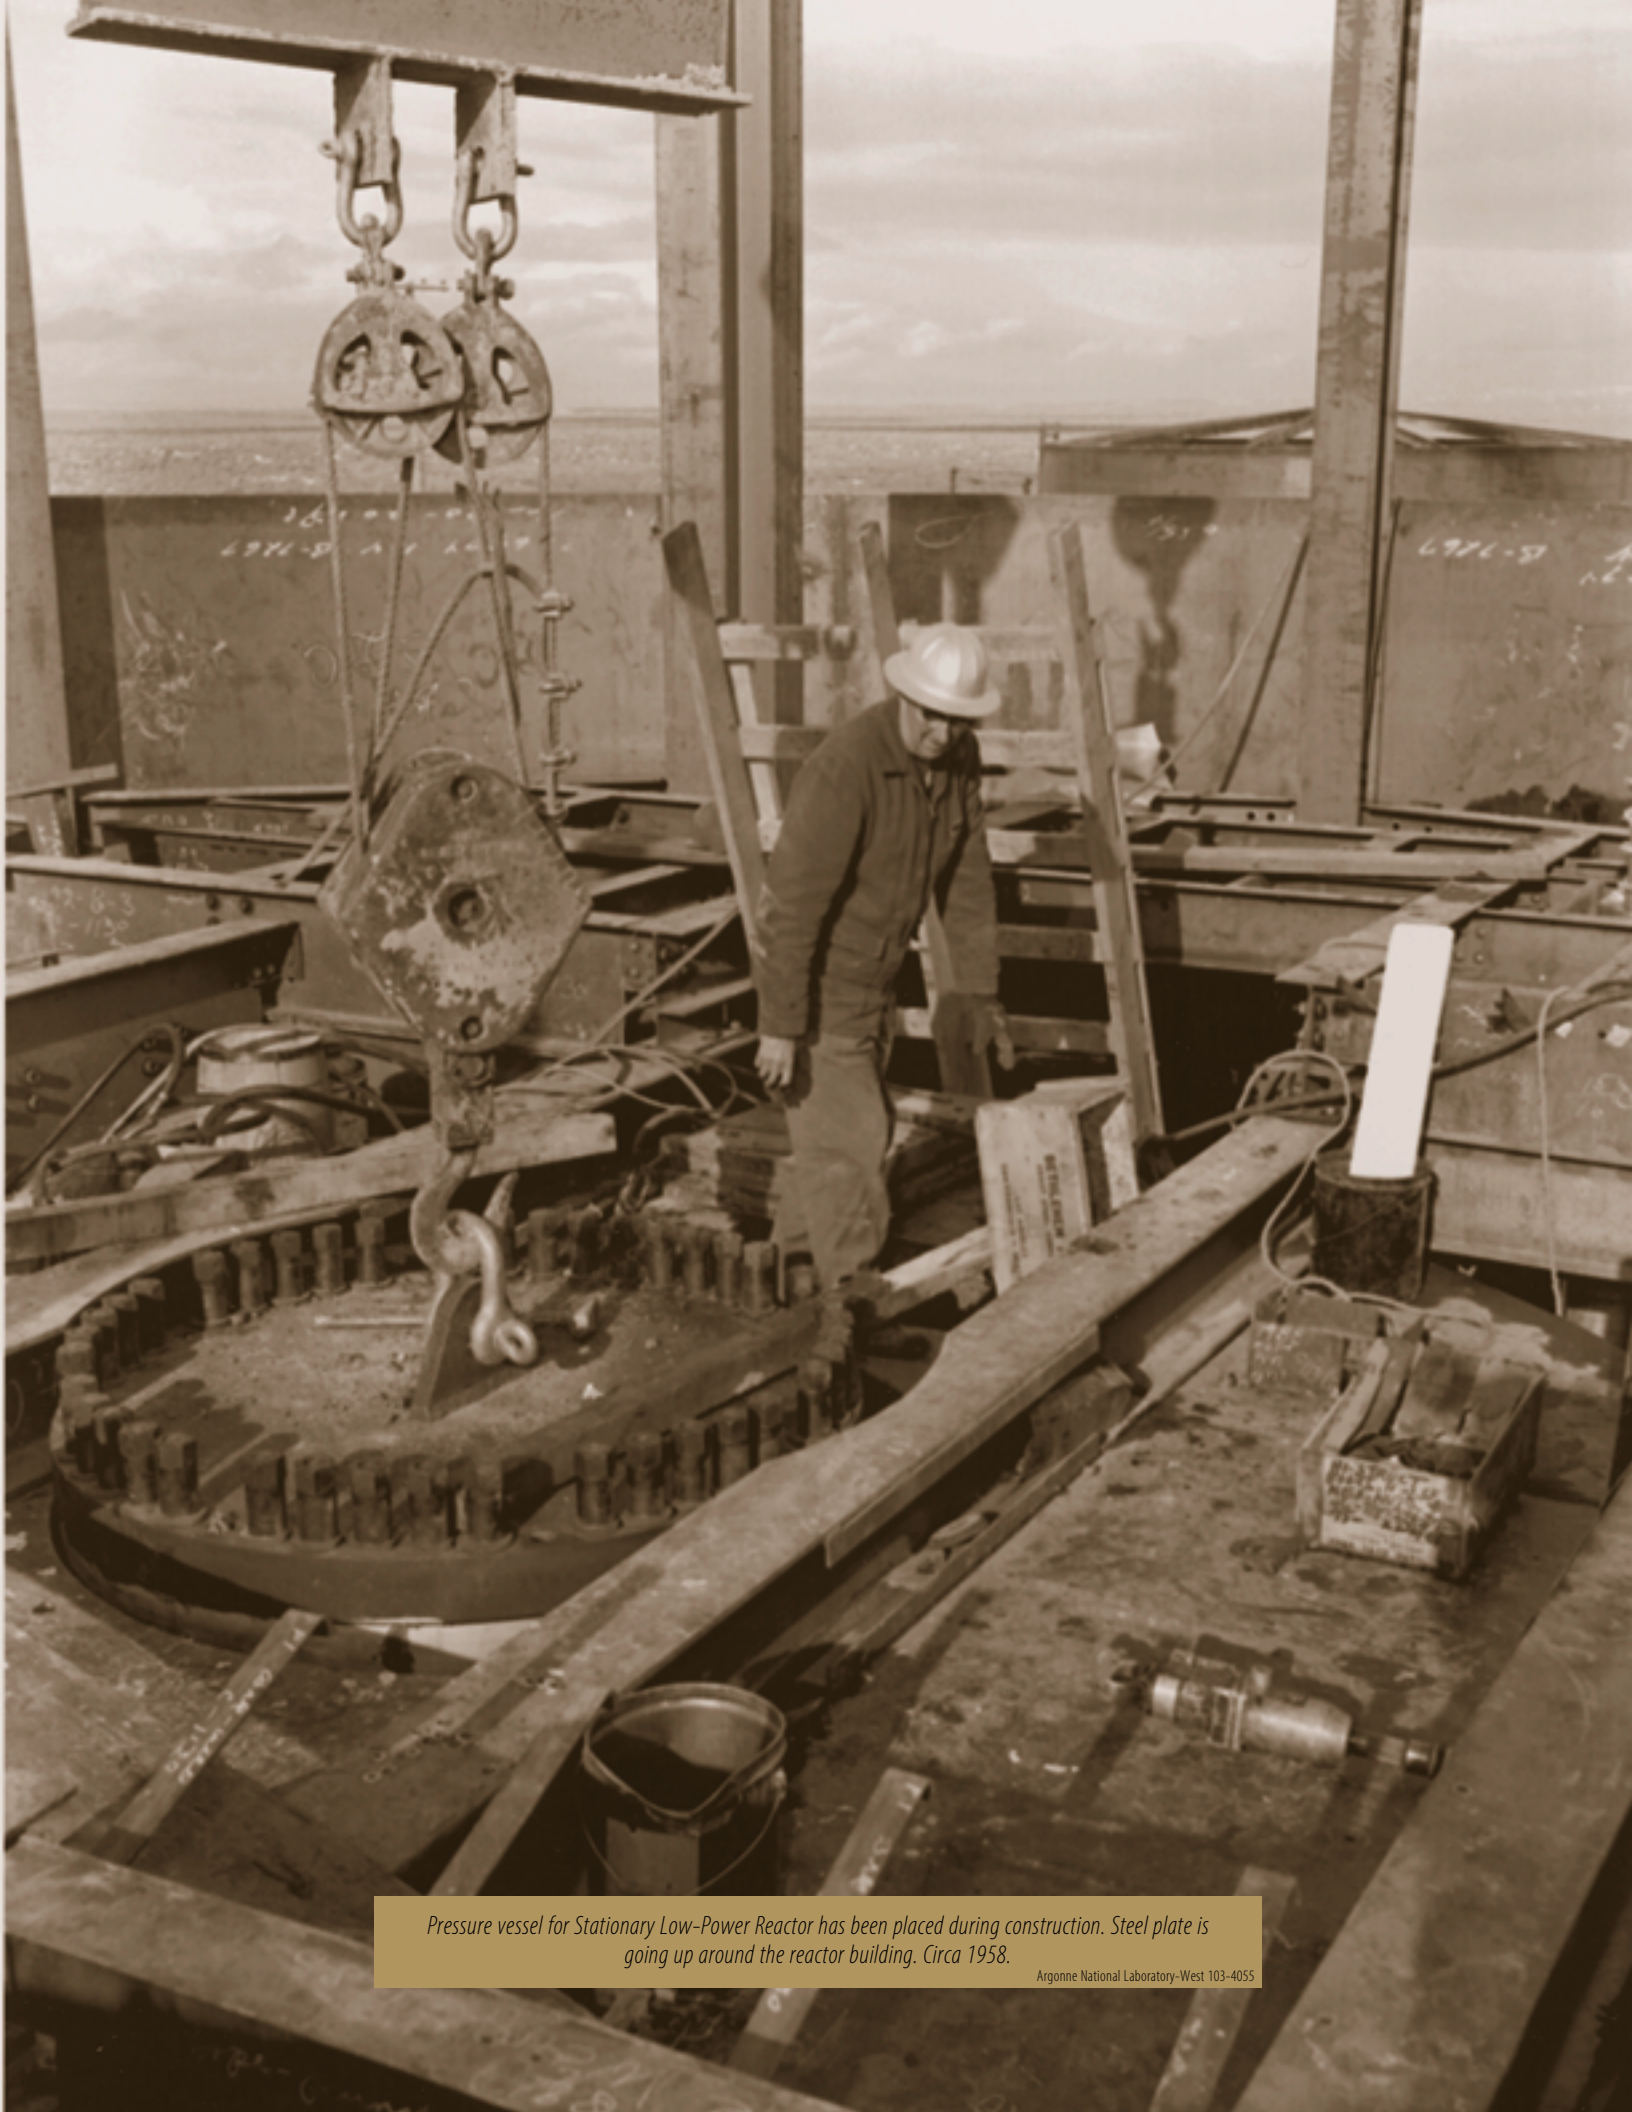
Argonne National Laboratory-West 103-4055

*Pressure vessel for Stationary Low-Power Reactor has been placed during construction. Steel plate is going up around the reactor building. Circa 1958.*

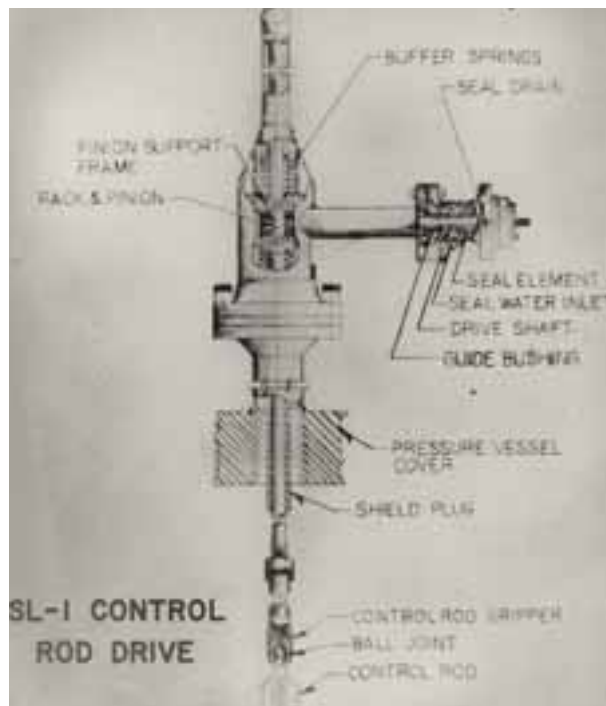
INEEL 61-203

Above. Enclosed stairway from SL-1 support building to operating floor of reactor silo. Left. The control rod drive mechanism. Note cruciform shape of control rod (bottom of drawing).

Reconnecting the drive mechanisms involved several steps, one of which was to lift the control rod—manually—about three inches out of the reactor. At the top of the control rod was a small ball. A “gripper” from the drive mechanism latched onto this ball, completing the connection between the rod and the rest of the mechanism and its motor.

The control rods were not cylindrical in shape, as the name “rod” might imply. Rather they were cruciform, with four narrow fin-like projections that moved up and down the length of the core in narrow sheaths. The fuel zone was nearly twenty-eight inches long. Moving the rods three inches was safe and not enough to invite a chain reaction.<sup>10</sup>

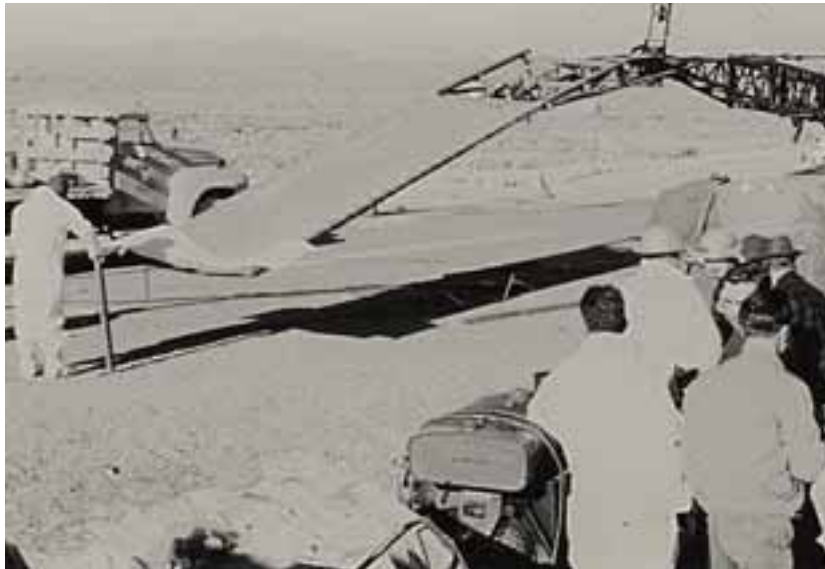
*The stretcher rig. Crews practiced before the rig was inserted into the reactor building to collect the body of the third man.*

the SL-1 erected at Central. They rigged a special net on the boom of a crane and positioned it to prevent the body or anything else falling onto the reactor. Metal workers shielded the crane operator's cab. On January 9, eight men, paired in two-man relays limited to sixty-five seconds inside the building, recovered the body and lowered it to the ground.<sup>25</sup>
