ANSI C119.4 Testing of TS Conductor "Ruddy" with AFL Connectors

Mechanical Test Results

NEETRAC Project: 22-132

Final Report

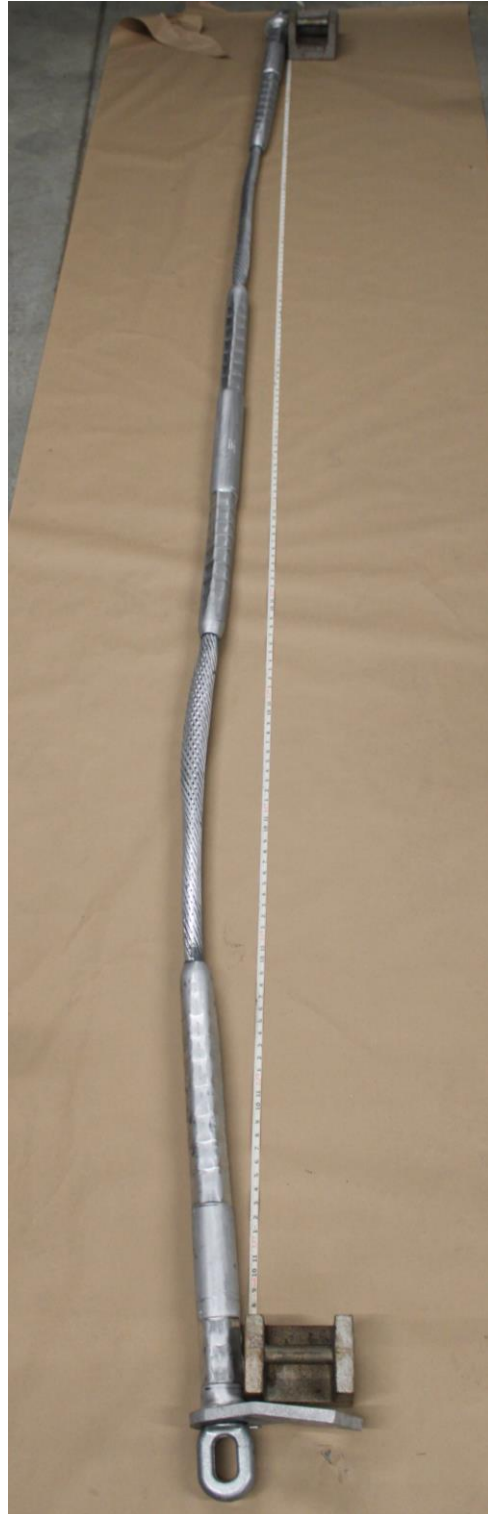
A typical sample with two dead-ends and one splice can be seen in Figure 1. Sample 1 and sample 2 were installed per AFL’s written instructions, which do not specify crimp orientation. All connectors in Sample 3 were installed using a constant crimp orientation for both the core grip and aluminum sleeve, with the intent of creating a “bow” in the connector. A photo of Sample 3 after assembly can be seen in Figure 2. The maximum chord height of Sample 3 was measured to be approximately 4 inches.

Figure 2: Initial Condition of Sample 3 – Crimped without Rotation

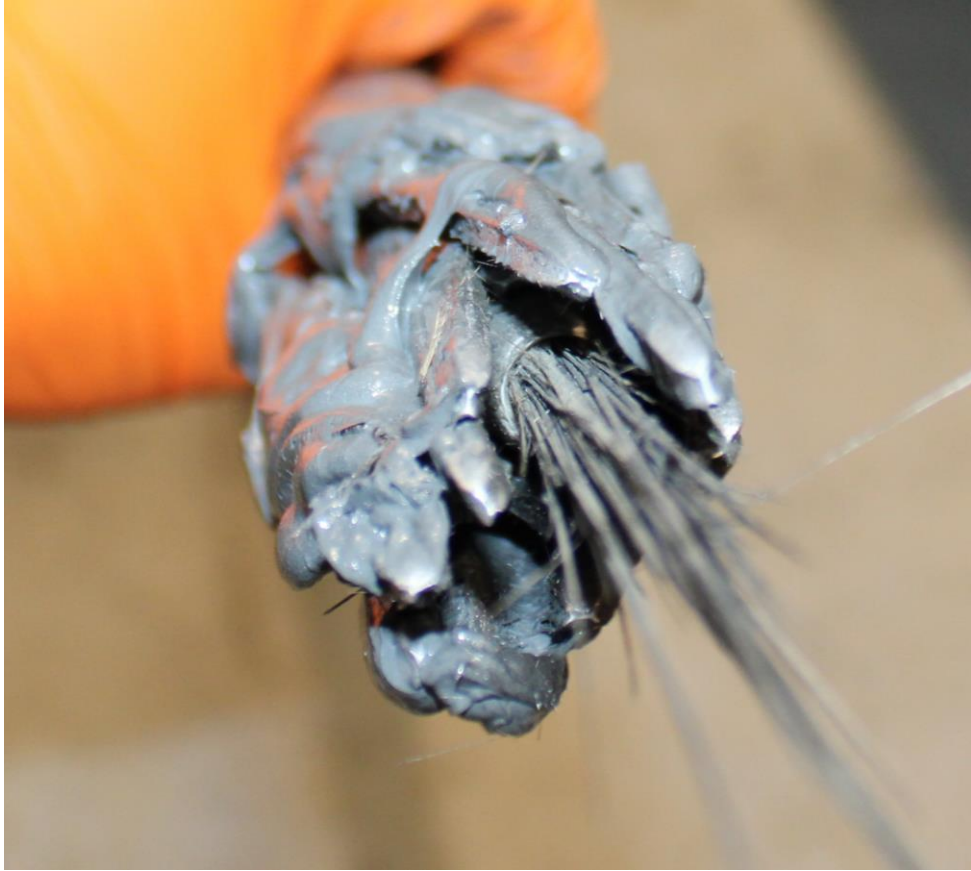
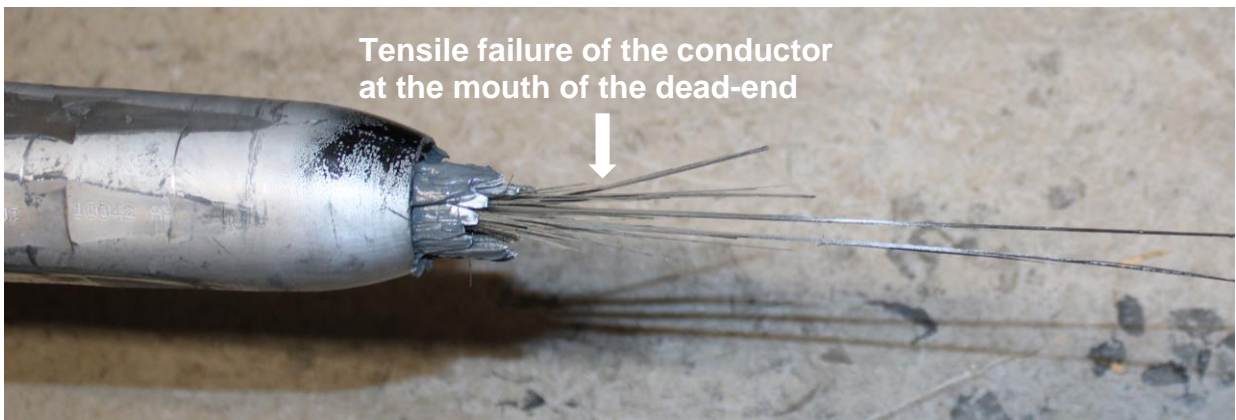
Sample 1 passed the sustained load test with no slippage observed. The data for the sustained load hold test can be seen in Figure 3. Sample 1 passed the pullout strength test with a maximum load of 47.0 kip (111% of the conductor's RBS) prior to failure. For a photo of the test sample after the pullout strength test refer to Figure 4 and Figure 5. The data for the pullout strength test can be seen in Figure 6.

Figure 4: Photo of Sample 1 after Pullout Strength Test (1 of 2)

Figure 5: Photo of Sample 1 after Pullout Strength Test (2 of 2)

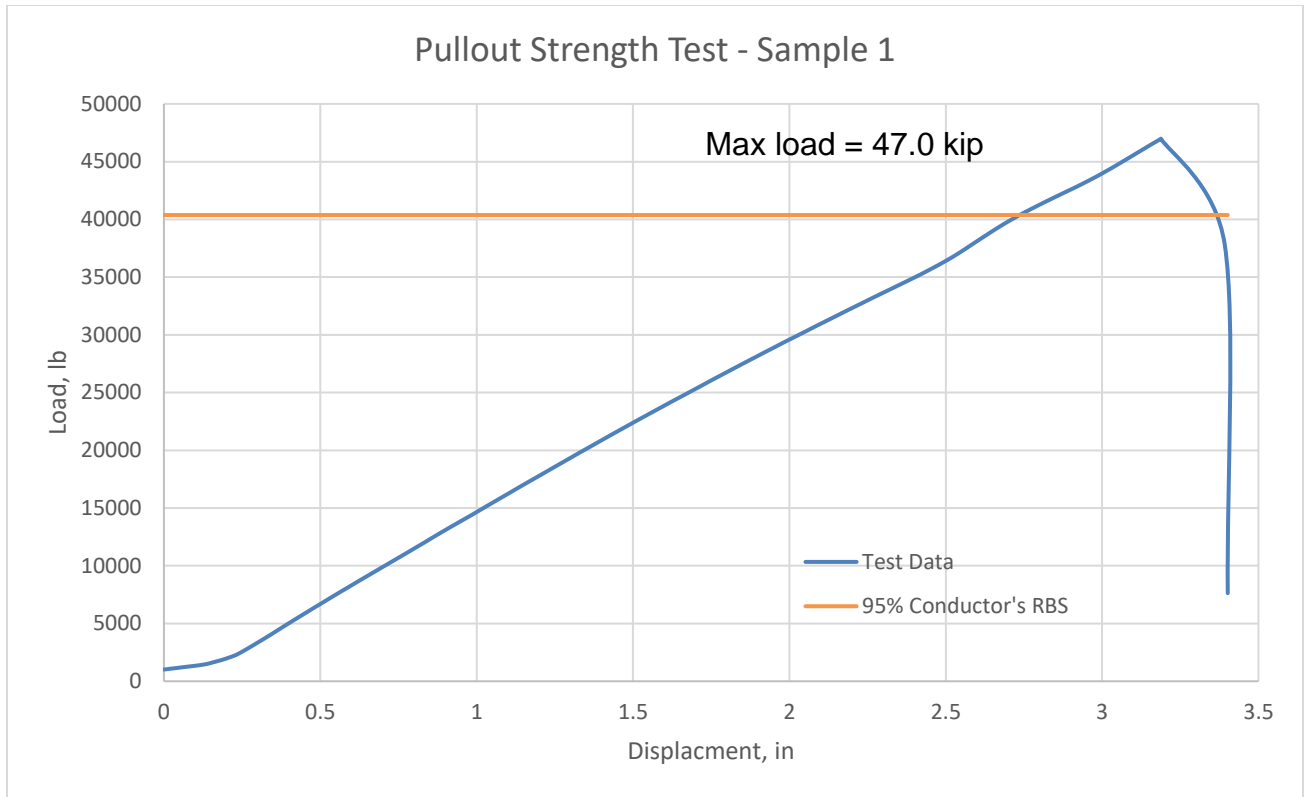
Figure 6: Pullout Strength Test Data - Sample 1

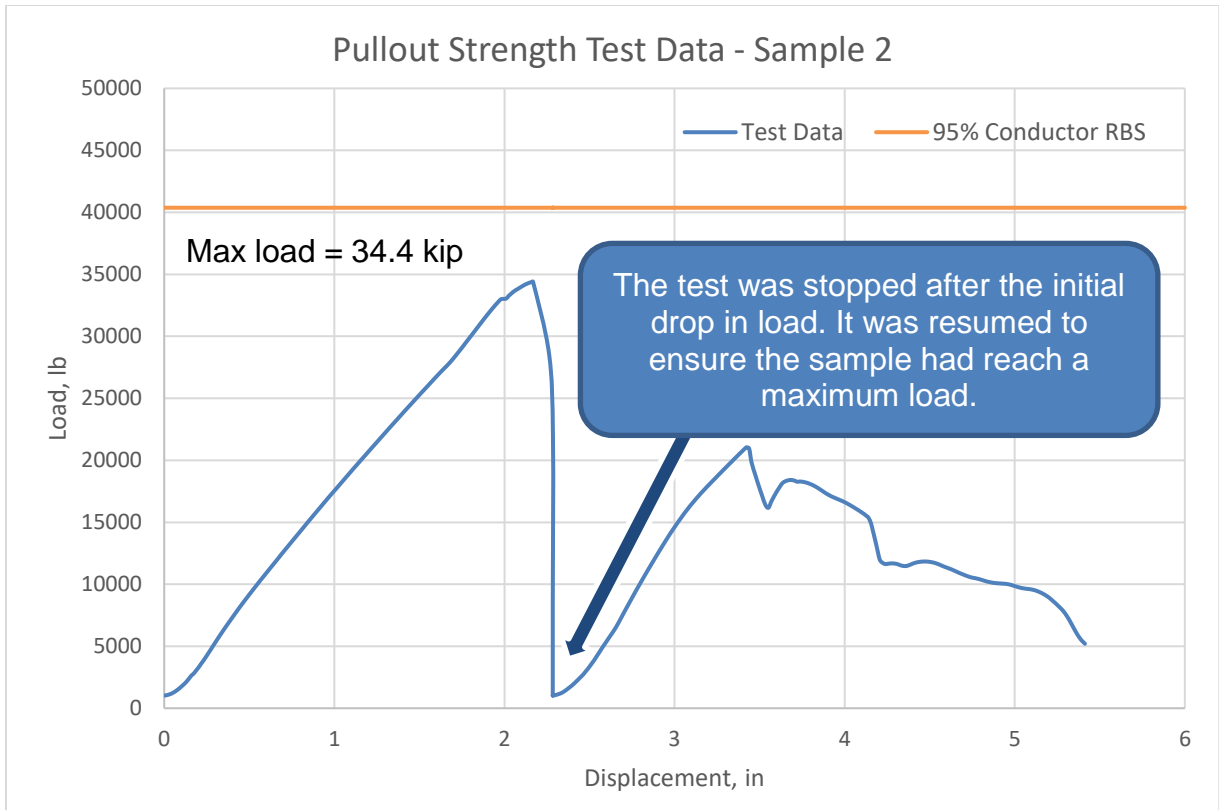
Sample 2 passed the sustained load test with no slippage observed. The data for the sustained load hold test can be seen in Figure 7. Sample 2 failed the pullout strength test as it did not reach 95% of the conductor's RBS prior to failure. The sample reached a maximum load of 34.4 kip (81% of the conductor's RBS). A photo of the sample after the pullout strength test can be seen in Figure 8. The data for the pullout strength test can be seen in Figure 9. Refer to Section 6 for a discussion of this failure.

Figure 9: Pullout Strength Test Data - Sample 2

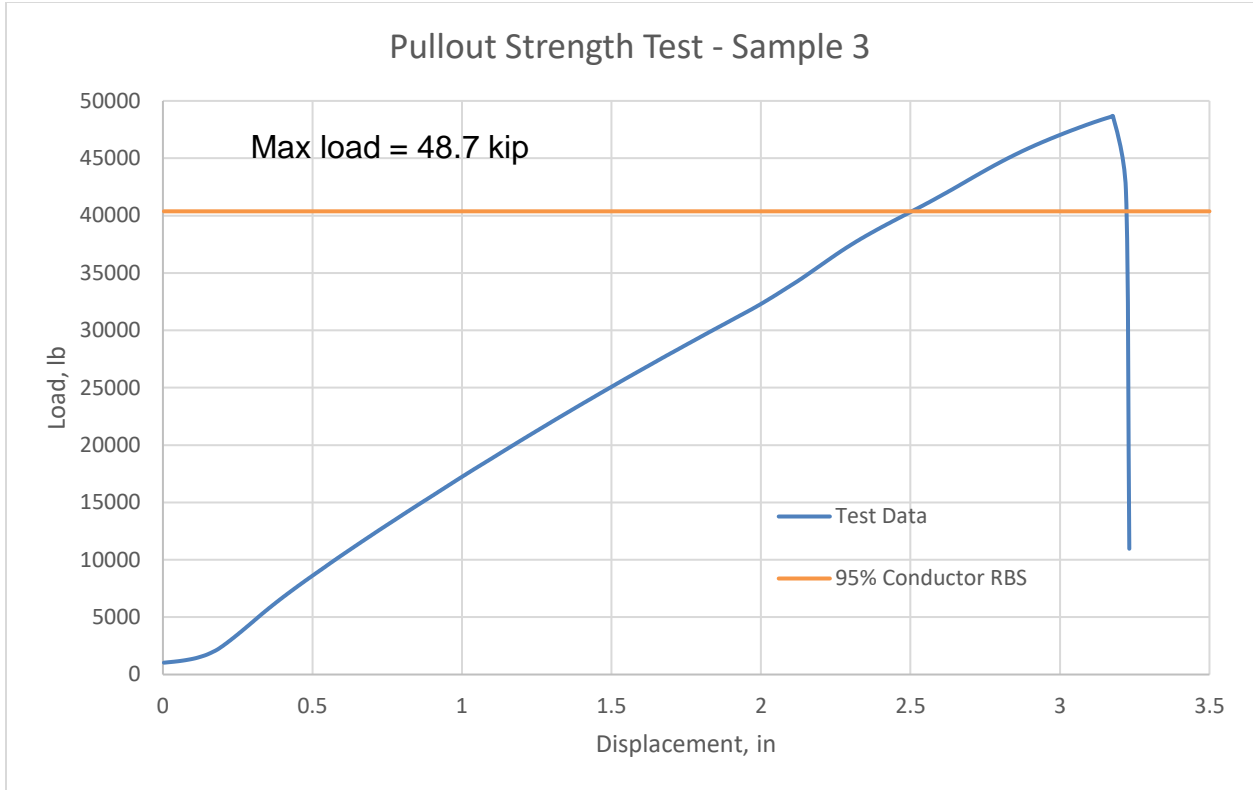
Sample 3 passed the sustained load test with no slippage observed. The data for the sustained load hold test can be seen in Figure 10. Sample 3 passed the pullout strength test as it reached a maximum load of 48.7 kip (115% of the conductor's RBS) prior to failure. A photo of the sample after the pullout strength test can be seen in **Error! Reference source not found.** The data for the pullout strength test can be seen in Figure 11.

Figure 12: Pullout Strength Test Data - Sample 3

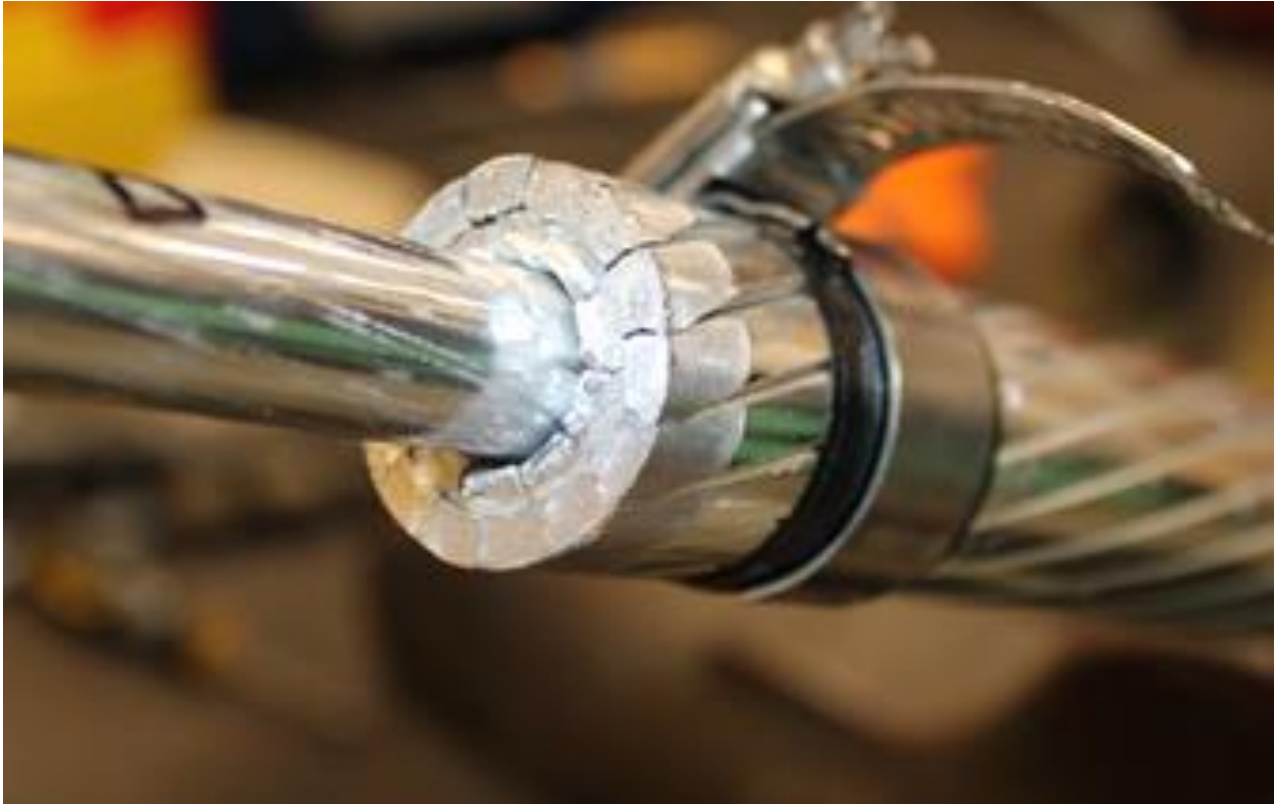
Photos taken prior to compression were reviewed to ensure the aluminum encapsulation of the carbon fiber core did not include any cuts, nicks, or other deformations. The condition of the core with the aluminum encapsulation can be seen in Figure 13.

Figure 13: Photo of the Core of Sample 2 prior to Dead-end Installation

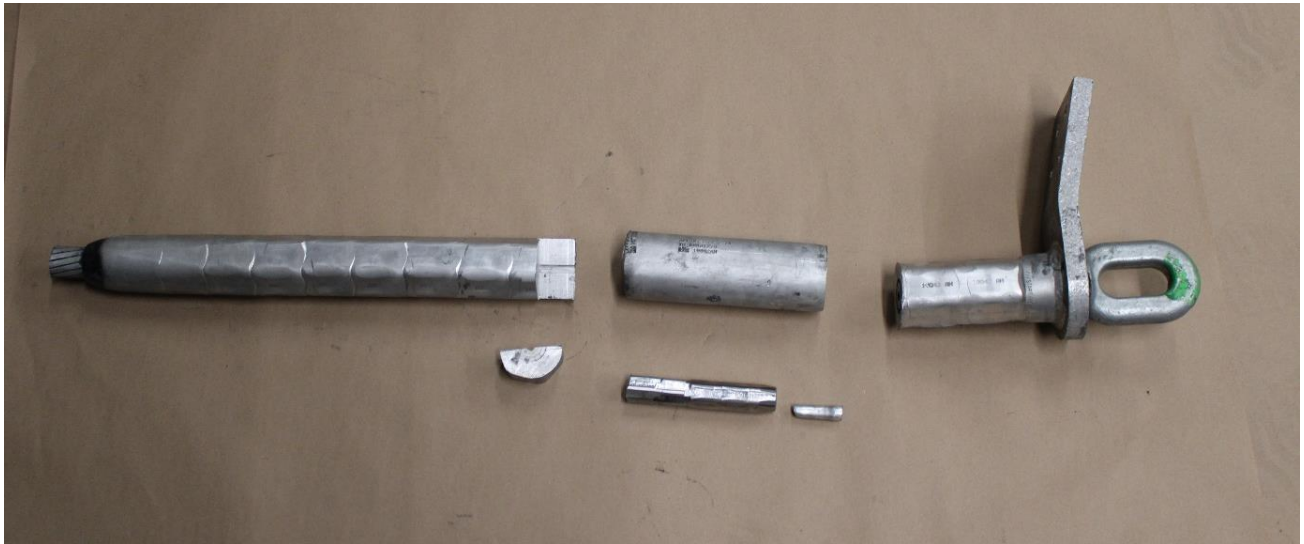
A dissection of the dead-end was performed to understand the nature of the failure. Refer to Figure 14 for a photo of the initial dissection. Upon opening the dead-end, it was determined that the carbon fiber core fractured approximately 1.75 inches inside the mouth of the core retention sleeve

Figure 14: Photo of the Dissection of Sample 2

NEETRAC will recommend a follow-up test program to attempt to replicate a shear fracture during the assembly process.

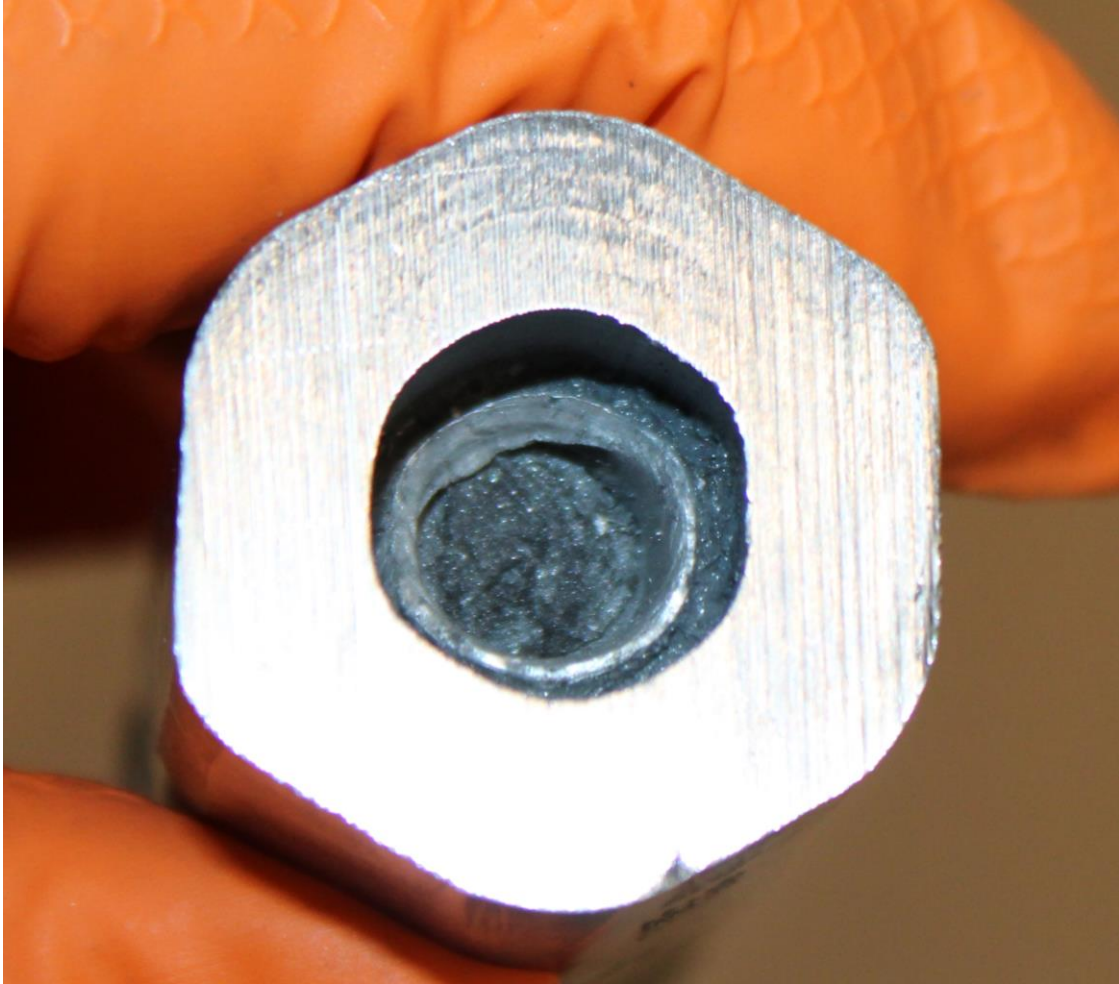
The failure of the core inside the steel barrel can be seen in Figure 15 and Figure 16. Observe that the aluminum encapsulation fractured at a different location. This was most likely caused because aluminum has greater elongation to break than carbon fiber composite. The mating surface of the failed core can be seen in Figure 17. Both sides of the fracture surfaces were visually inspected using an optical microscope; photos from the microscopic examination can be seen in Figure 18 and Figure 19.

Figure 15: Sample 2 - Location of Failure - Inside of Steel Pin (1 of 2)

Figure 16: Sample 2 - Location of Failure - Inside of Steel Pin (2 of 2)
