Citation: INL, "TS Bend Test Report", Idaho National Laboratory with Electric Power Research Institute, 2026.  
<https://inl.gov/national-security/advanced-grid-solutions/>

# TS BEND TEST REPORT

EPRI Test Results

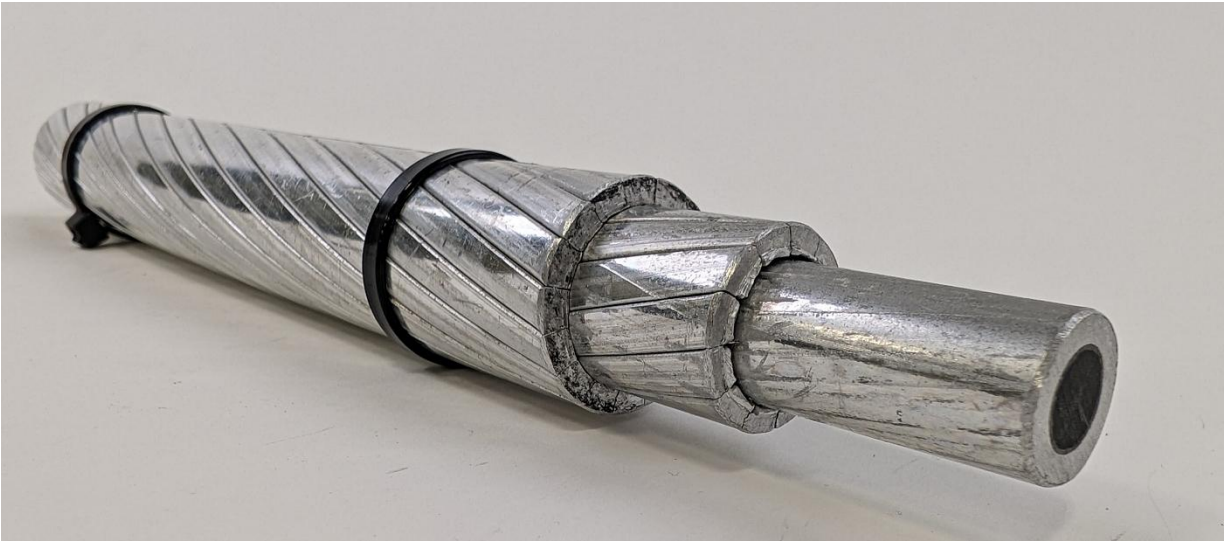
Figure 1. TS conductor tested

The test object was the TS (Jackson) M3 8.5 (28.727) Aluminum Encapsulated Carbon Core (AECC) conductor. This conductor uses a high-strength TS composite core as the primary tensile member and fully annealed trapezoidal aluminum strands as the current-carrying component. For this evaluation, the bend-under-tension and tensile tests focused on the response of the composite core after removal from the conductor assembly, while the conductor rating and geometry were used as the basis for test setup and performance comparison. A photograph of the conductor is shown in Figure 1, and the relevant conductor specifications are summarized in Table 1.

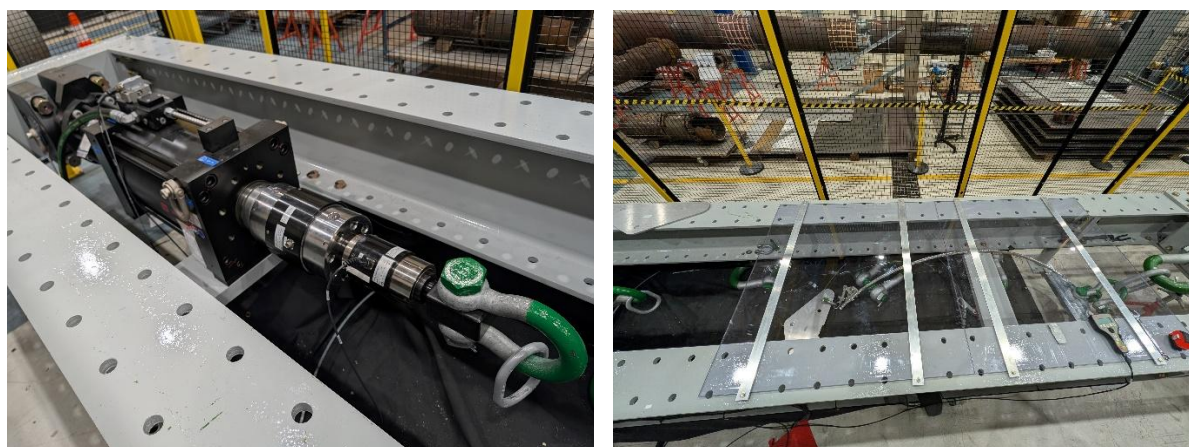
Figure 2. Horizontal Tensile Tester

For each bend test, the selected sample was installed in the horizontal tensile tester and routed around the assigned mandrel. The sample ends were secured in the grips and connected to the yoke-plate assembly so that the core could be tensioned while maintaining a 180-degree wrap around the mandrel. The test configuration is shown in Figure 2.

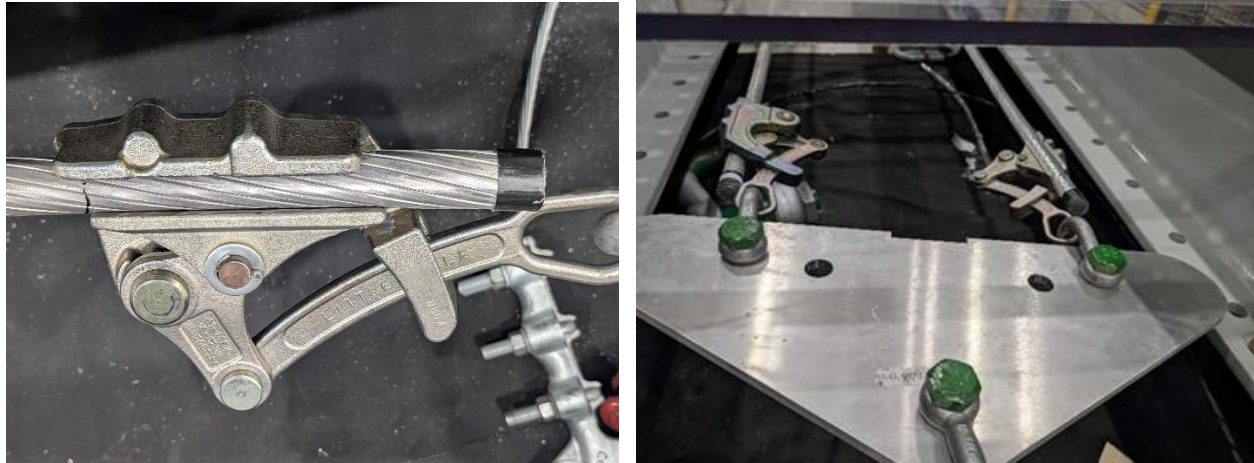
Figure 3. Conductor Grip and Yoke Plate

After installation, the sample was loaded to 15% of the core rated breaking strength and held at that load for one minute. The load was then released, and the sample was removed from the mandrel and yoke-plate assembly for visual inspection. The conductor grip and yoke-plate arrangement used during the bend tests is shown in Figure 3.

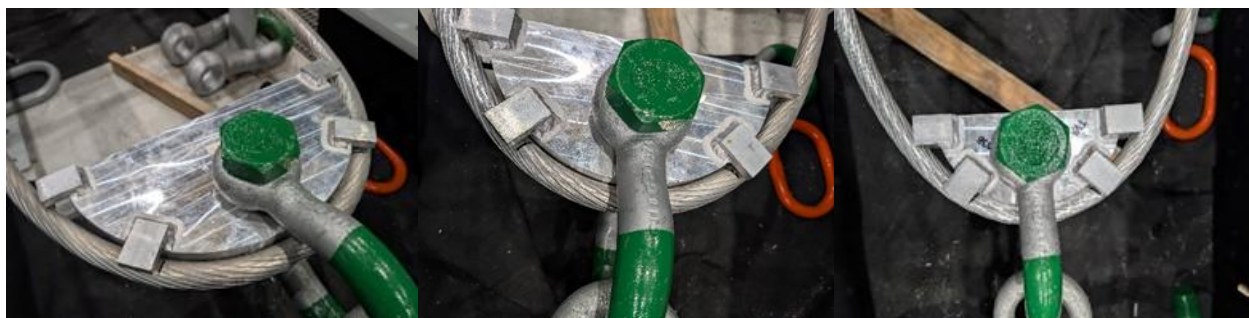
Figure 4. 50x Mandrel; 40x Mandrel; 30x Mandrel

The mandrels were mounted on the fixed back plate of the test frame and were selected according to the assigned bend condition. Using interchangeable mandrels allowed the same sample support, gripping, and loading arrangement to be used for all bend tests while varying only the bend radius. The 50x, 40x, and 30x mandrels are shown in Figure 4.

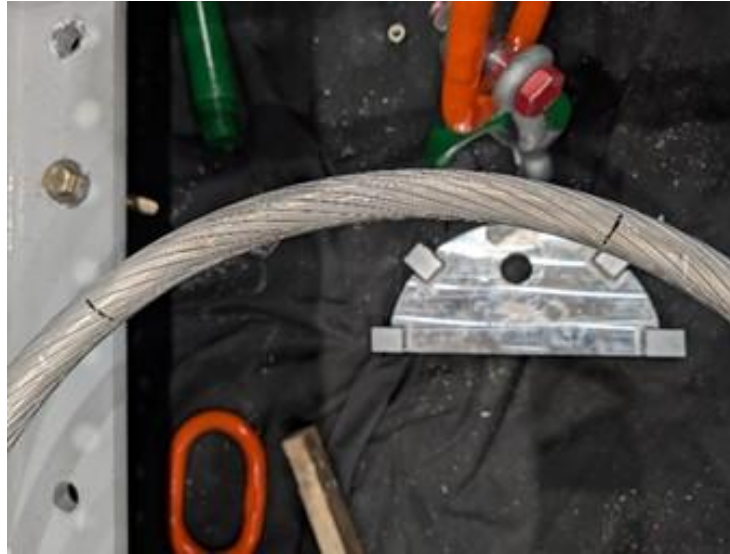
Figure 6. 50x Sample after bend

Samples tested on the 50x mandrel exhibited minimal visible damage after the bend exposure. Minor scuffing and small surface imperfections were observed near the mandrel contact region, but no major visible cracking, fiber disruption, or permanent deformation was noted. The post-bend condition was consistent with expectations for the ASTM B987 baseline bend radius.

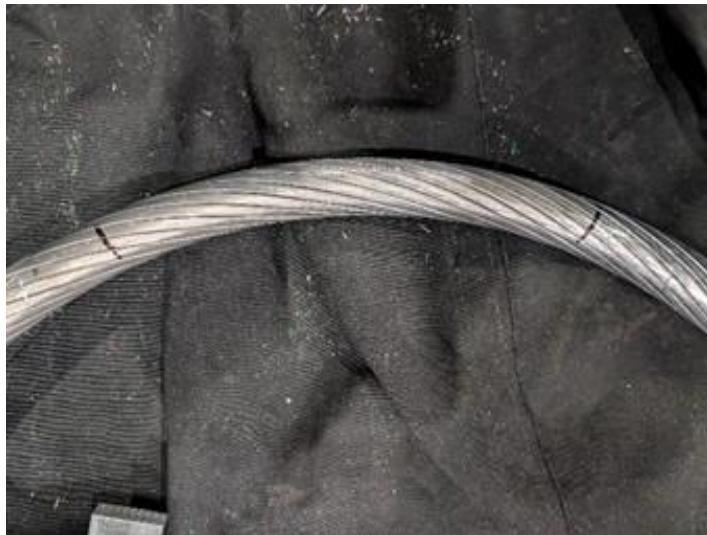
Figure 7. 40x Sample after bend

Samples tested on the 40x mandrel showed visual characteristics similar to the 50x samples. Minor surface marks and localized imperfections were observed, but no significant visible damage or permanent set was evident after removal from the mandrel. These observations indicate that reducing the bend radius from 50x to 40x did not produce a clear change in the visual condition of the tested samples.

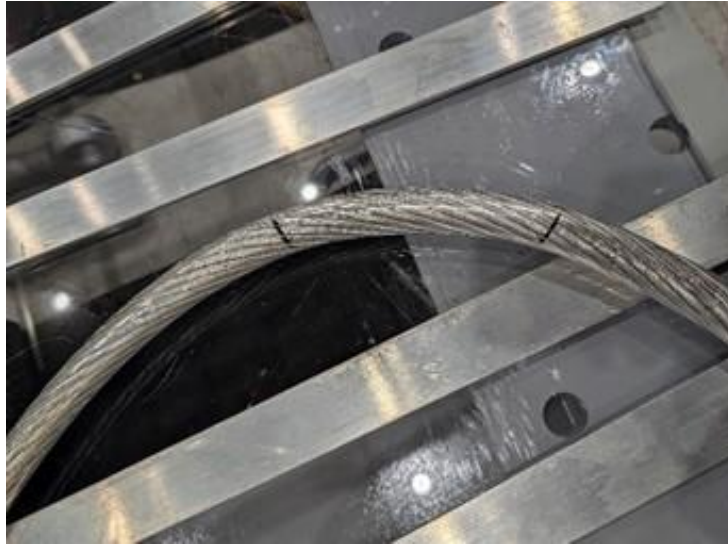
Figure 8. 30x Sample after bend

Samples tested on the 30x mandrel showed the most visible response among the bend-test groups. Localized flexing was observed at the mandrel contact region during loading, and audible popping sounds were noted during the bend exposure. After unloading and removal from the mandrel, the samples remained intact but showed a visible permanent bend. The audible events could not be attributed to a specific mechanism based on visual inspection alone; however, the post-bend deformation indicates that the 30x condition imposed a more severe bend exposure than the 50x and 40x conditions.

Overall, the visual observations indicate that bend-test severity increased as bend radius decreased, with the most notable response occurring at the 30x condition.

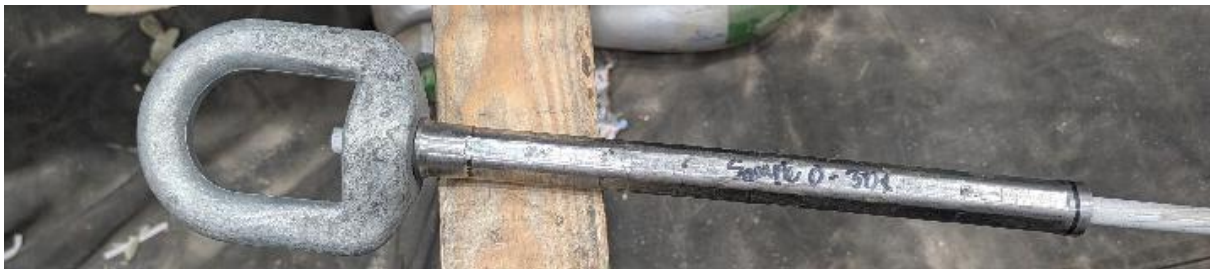
Figure 9. Prepared TS Composite Core with Steel Tube

The aluminum strands were removed from each end of the TS conductor to expose the composite core. The exposed core surface was cleaned, and threaded steel tubes were crimped onto both ends. A dead-end eye was attached to each threaded tube. The prepared samples were installed in the same horizontal tensile test rig used for the bend test, with the dead-end eyes connected to the rig using shackles. Each sample was then loaded in tension at a crosshead rate of 19 mm/min until failure.

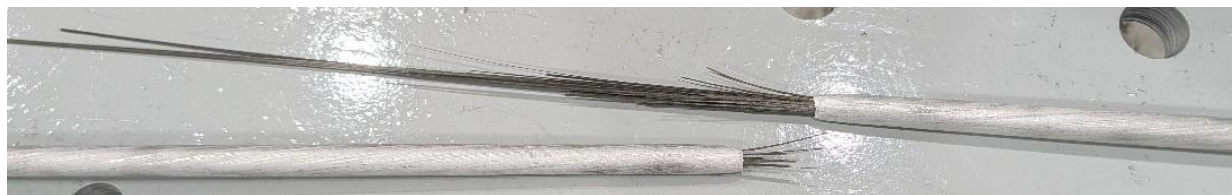
Figure 11. Post-test condition of Sample 1

Sample 1, which was subjected to the 50x bend condition, reached a maximum tensile load of 43,868.1 lbf before failing near the center of the sample. The failure occurred within the previously bent region; however, the measured load exceeded the conductor rated breaking strength of 42,510 lbf by 1,358.1 lbf, or approximately 3.2%. Post-test inspection showed ductile deformation of the aluminum encapsulation and separation of the carbon core, as shown in Figure 11. Based on the retained tensile capacity, the failure location alone does not indicate a measurable strength reduction associated with the 50x bend condition.

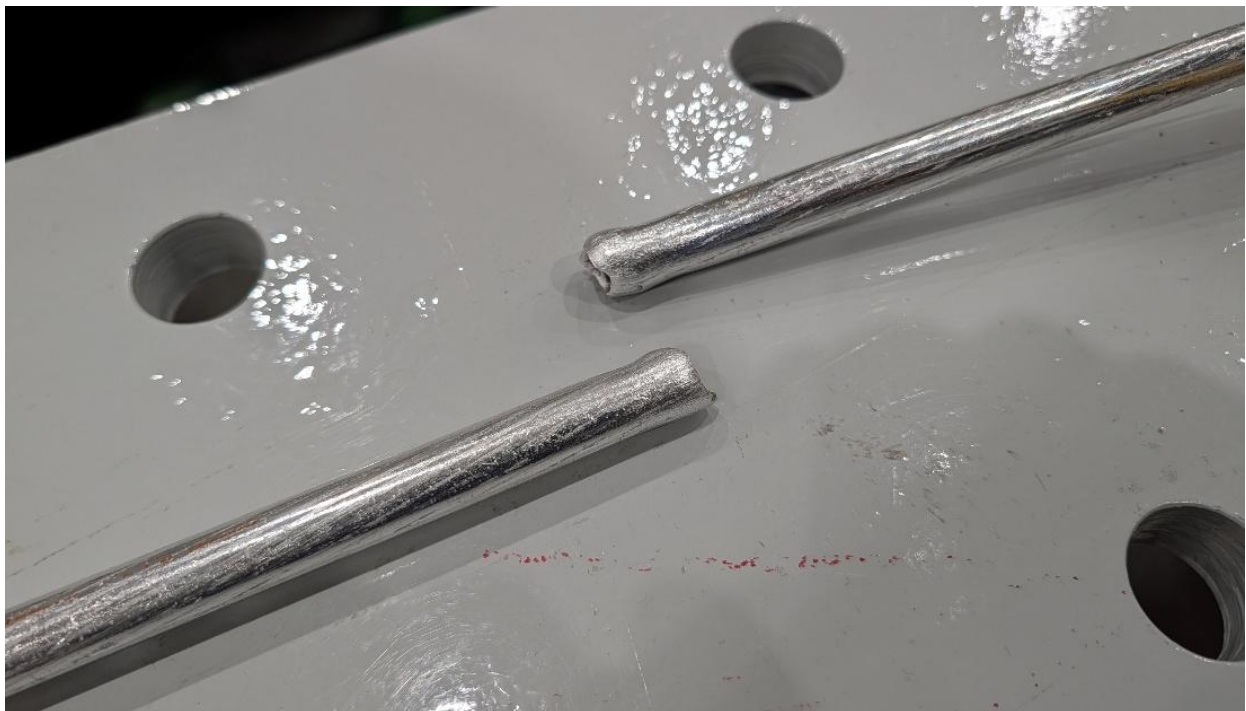
Figure 15. Post-test condition of Sample 5

Sample 5, tested at the 30x bend condition, reached a maximum tensile load of 38,529.9 lbf before failing near the center of the sample. The fracture occurred within the previously bent region. Post-test inspection showed ductile deformation of the aluminum encapsulation and fracture of the carbon core, as shown in Figure 15.

The measured load was 3,980.1 lbf below the conductor rated breaking strength, corresponding to approximately 90.6% of rated capacity. This result indicates a reduction

in residual tensile strength after the 30x bend exposure, although the sample retained substantially more capacity than Sample 6.

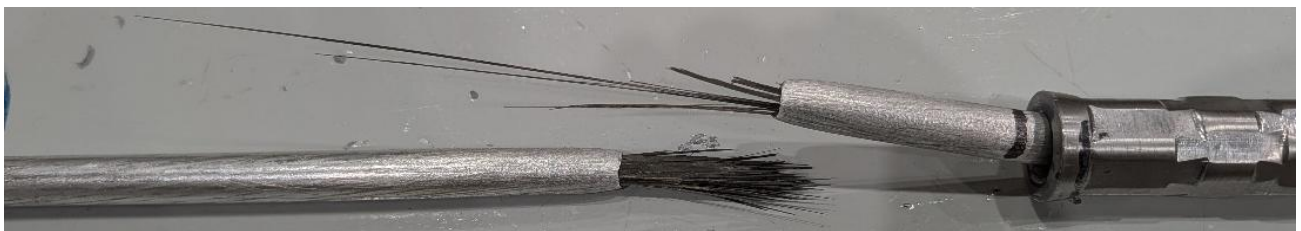
Figure 19. Post-test condition of Sample 8

Sample 8 was the second unbent control sample and reached a maximum tensile load of 42,508.8 lbf before failing near the holding side of the sample. Post-test inspection showed ductile deformation of the aluminum encapsulation and separation of the carbon core, as shown in Figure 19. The measured load was essentially equal to the conductor rated breaking strength and above the 95% acceptance threshold used for comparison, confirming that the second control sample met the expected tensile-strength requirement.
