# EV-EVSE Fault Study

An Analysis of Thermal Events Caused by  
Electrical Faults during DC Charging

JUNE 2025

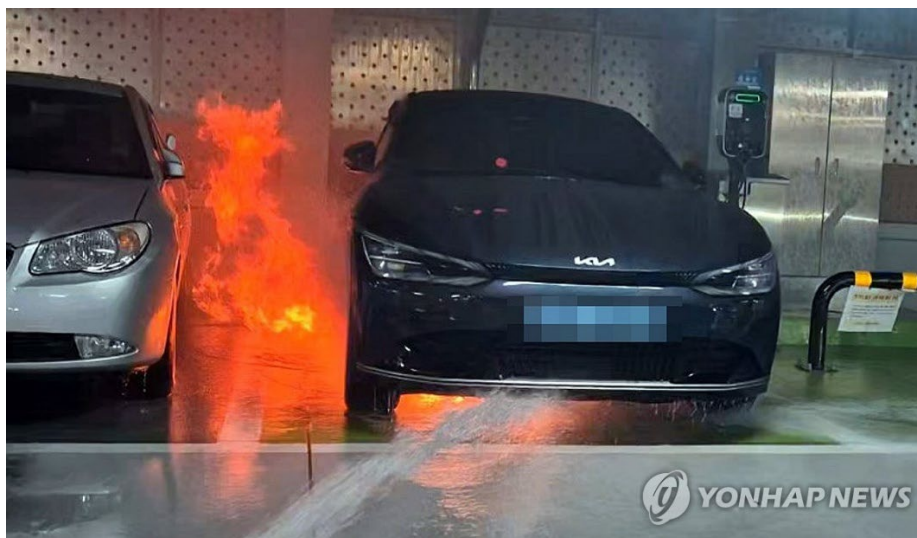
**Figure 1: August 2024, South Chungcheong Province, South Korea (Yonhap News Agency)**

In 2024, there have been three high-profile fire incidents in parking structures in South Korea involving EVs.<sup>7</sup> One of the incidents, photographed by the local fire department and shown in Figure 1, involved an EV that was connected to a charger when an overtemperature event triggered a sustained battery fire. All three incidents involved different brands of vehicles and different battery vendors yet are notable in their impact. For example, one of the incidents damaged 140 vehicles and caused injuries to approximately 22 people, including a first responder. In cases such as the incidents in South Korea in which the battery was involved in sustaining—if not initiating—the fire, the focus of forensic investigations rightly remains on improving battery safety.

Returning to the incident pictured in Figure 1 and the two other high-profile fires in South Korea, there is evidence of the concepts of a systems approach being used to reduce risk in the response from authorities. New measures considered include improving transparency for the consumer about the manufacturing source and vendor of the vehicle battery. This step would improve the efficiency of a fault analysis by documenting a fault path from the terminal fault of an EV fire to potential manufacturing deficiencies with a particular vendor. Other proposals include limiting EV state of charge and charging limits in enclosed parking structures and restricting EVs from underground parking lots. Both measures illustrate a balanced risk mitigation approach by considering components in the fault path external to the battery. Limits on state of charge and charging limits are aimed at reducing the likelihood of overcharging-related thermal failure, while restrictions on the number and location of EVs in enclosed parking structures are aimed at reducing the impact of a vehicle fire. As noted earlier, risk is computed as the product of likelihood and some metric of impact. Including component-level risk factors in a structured fault tree would be valuable to not only identify contributing critical components but also to quantitatively determine the reduction of overall risk in terms of changes to specific components or groups of components.

Returning to the illustrative examples in Figure 1 and Figure 2, the EVSE was also damaged in the resulting vehicle fire. While it is unclear in these cases if the damage was due to thermal exposure after the EV ignited or if an electrical fault also occurred in the EVSE, there are several examples of cases in which faults similar in origin to the example in Figure 4 caused damage to the coupled EVSE. Another example is shown in Figure 5. The opposite causality is also common in which an electrical short originating in an EVSE has caused damage to an EV. An EVSE installation failure has been posited as a possibility in the EV fire shown in Figure 6.

As temperature continues to increase and as pressure from the gaseous products from electrolyte decomposition continues to rise, the electrolyte can ignite, and the battery can rupture, potentially leading to fire and explosion, which is the terminal fault state illustrated in Figure 1.

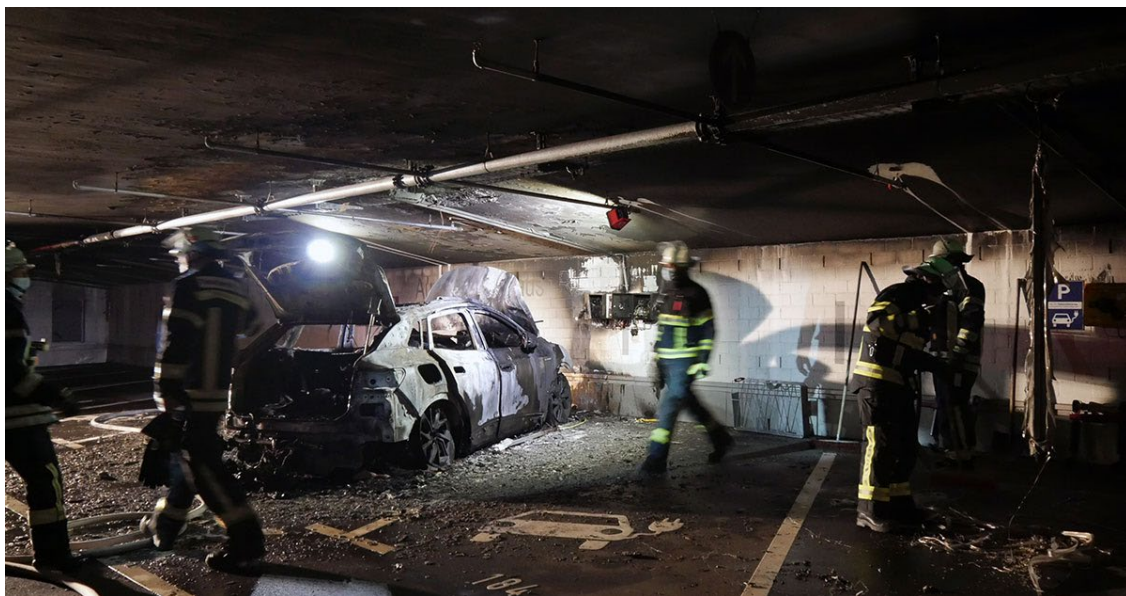
**Figure 2: November 2021, Ravensburg, Germany (Wochenblatt News)**

In contrast to the cases discussed earlier where the terminal state of the EV charging fires was a sustained lithium battery fire, many EV charging fires do not terminate in thermal runaway and combustion of the battery cells. Figure 2 shows a widely reported incident in a parking garage in Ravensburg, Germany.<sup>8</sup> This incident had significant damage impact, including exposure ignition of adjacent vehicles and damage to the building structure. Indications from preliminary analysis indicate that the primary ignition may not have directly been caused by a battery fire. Instead, it is likely that the trigger condition was an electrical short or arcing event near the point of connection between the EV and the charging connector, which is referred to as the connector-inlet interface. In fact, a similar make and model of the EV displayed an electrical fault originating near the connector-inlet interface when charging at a DC fast charger in California in 2023. In the latter case, a bystander was able to record video of the onset and progression conditions, shown as a sequence of screenshots in Figure 4. The flames first appear around the connector-inlet interface. Damage after fire suppression also appears to be localized around the connector-inlet interface and the rear quarters of the vehicle.

Returning to the incidents in Figure 2 and Figure 4, assuming that the originating faults were the same for both incidents and comparing the observations in the two events two years apart, a diagnostician may conclude that some component other than the OBC may have a role. There are several components in the charging circuit to consider. In several cases that seem to present a similar fault evolution pattern as the incidents in Figure 2 and Figure 4, it has been noted that failure of grommets, connectors, and cables between modular components in the charging path had contributed to the eventual faults to ground. As can be seen in Figure 3, the EV battery can serve as a source for fault currents depending on the location of an electrical wiring fault to ground causing what is called a battery-fed electrical short. Modern EV batteries store around 100 kW-h or 360 Megajoules of energy, which in thermal terms would be equivalent to approximately 15 liters of burning gasoline. Coupled with the rapid heat release rate of an electrical fault, there is sufficient energy in the battery to cause a fully involved vehicle fire even if the battery itself did not ignite. A determination that wiring defects and insulation failures could trigger battery-fed electrical shorts has motivated some manufacturers to issue voluntary inspection recalls;<sup>9</sup> for example, a recent National Traffic and Motor Safety Act mandated 49 CFR Part 573 Safety Recall.<sup>10</sup>

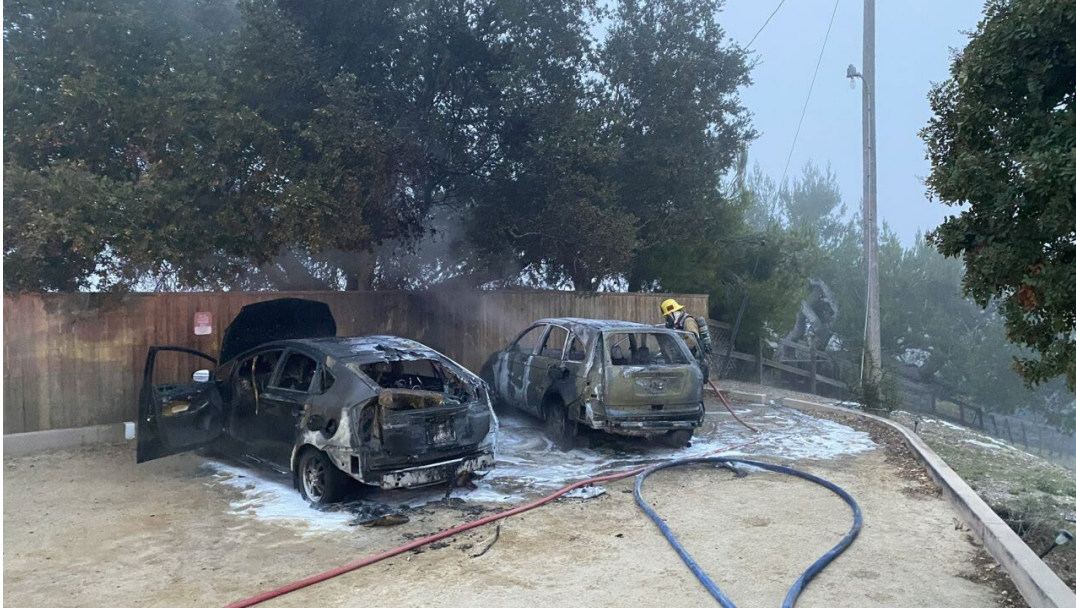
**Figure 6: November 2022, Los Alamos, California (Santa Barbara County Fire Department)**
